2. Summary

3. Conveyor 1 –

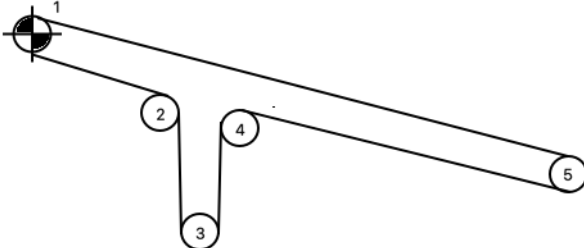
Conveyor System			
Specification	600mm wide 3 ply PN800	Length	48m
Belt Condition	Satisfactory		
Join/s	Cold Splice		
Join Condition	C/S skive lifting in centre – Repairs required		
Tracking			
Head	Satisfactory		
LTU	Satisfactory		
Tail	Belt rubbing on RHS structure		
Build-up / Spillage			
Head	Satisfactory		
LTU	Satisfactory		
Tail	Build up under tail pulley

Skirting	
		LHS	Approx. 1m torn
		RHS	Adjustment required
		Belt Cleaner	
		ESS - Counterweight cleaner	Satisfactory
		Dust Sprays	
		Head	Satisfactory
No.	Lagging	Condition	
1	12mm part ceramic	Satisfactory	
2	12mm diamond groove	Centre worn 60%	
3	12mm diamond groove	Satisfactory	
4	12mm diamond groove	Centre worn 60%	
5	Steel shell	Satisfactory
